**KOOTENAI DEVELOPMENT IMPOUNDMENT DAM  
DECEMBER 26<sup>TH</sup>, 2007 ROUTINE INSPECTION REPORT**

**BILLMAYER & HAFFERMAN ENGINEERING INC.**

**February 23, 2008**

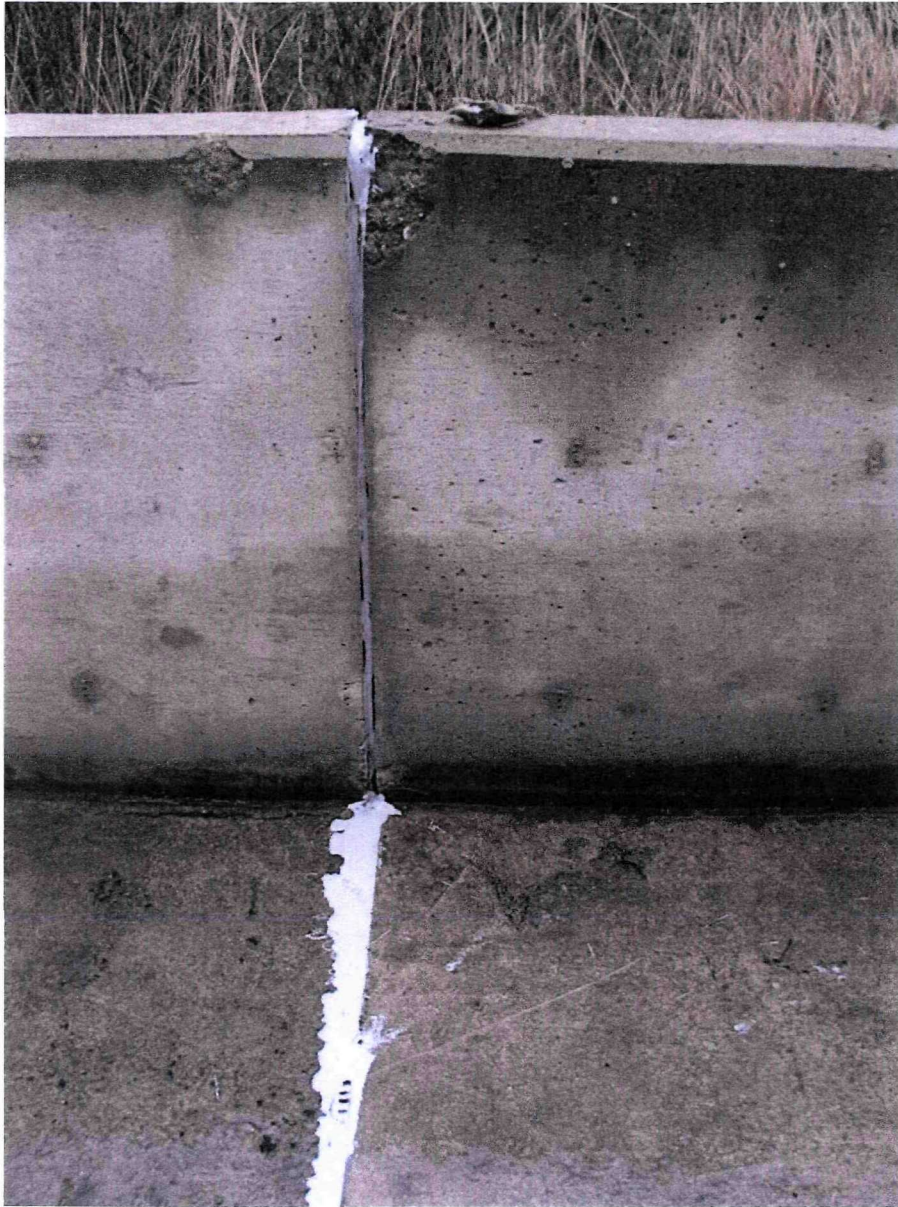
**Figure 1 Second Transverse Joint at top of Open Chute Spillway**

All of the side wall load cracks and the stress cracks were first ground out with a diamond tipped blade on a hand held grinder. The cracks were cleaned and then filled with a stiff Sika Flex™ caulk. Each of the transverse expansion joints was also cleaned out and when necessary, a foam backer rod was installed in the joint and then the joint was filled over with the flowable Sika Flex™ caulk. The vertical side expansion joints were also cleaned, a foam backer rod installed and a stiff non flowable Sika Flex™ was used to cover the backer rod and joint. A photograph of the second transverse joint at the outlet from the box culvert is shown in Figure 1 below. The photograph shows the flowable and non flowable caulk difference.

All of the rest of the transverse expansion and vertical expansion joints in the spillway were cleaned and filled. The photograph above shows areas in the vertical joints where the backer rod moved or the caulk did not bond to the sides. Chapman Construction was instructed to go back and clean the sides again and reapply the caulk. These clean up projects will be completed in the spring of 2008.

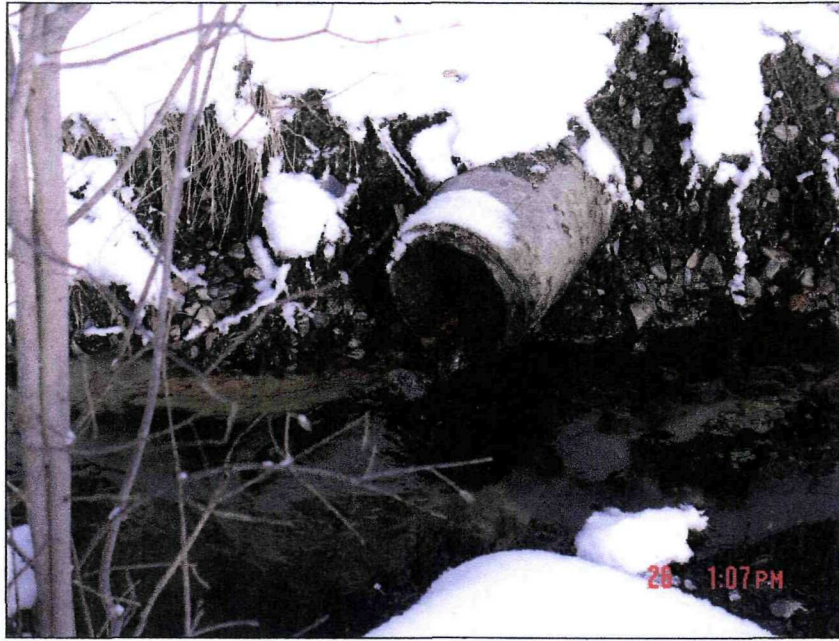
**Figure 2: Drain 4**

Drain 4: An 8-inch concrete pipe, with the bell end sticking out, in the left side, approximately 50 feet from left groin. The drain was flowing water and the flow was clear. The flow amount was typical for this drain. A photograph on the day of the inspection is shown in Figure 2 below;

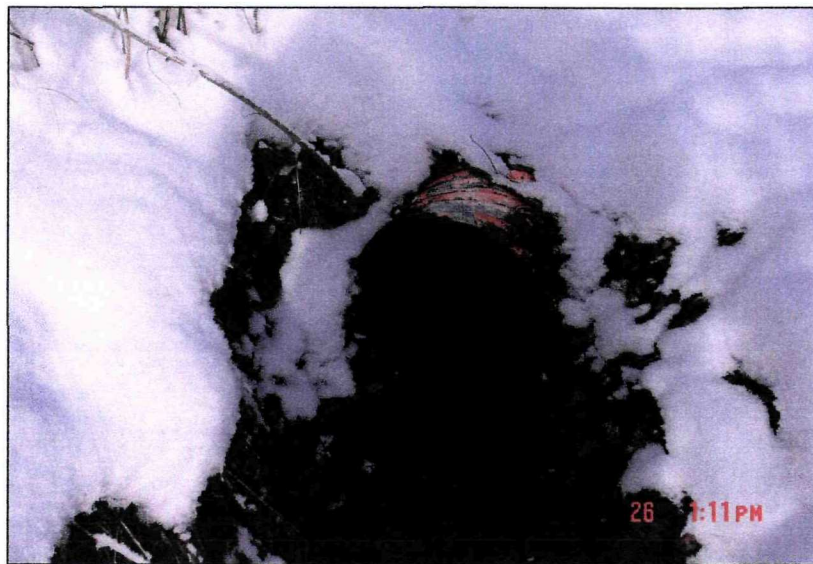
**Figure 3: Drain 5**

Drain 5: Is a corrugated metal pipe near the center of the dam. The drain had a small amount of flow. The amount of flow is typical for this drain. The V-notch weir below this drain was noted as being 1 inch which is a flow of 2.35 gpm. The flow in the November 9<sup>th</sup> inspection was  $\frac{3}{4}$  inch which is 1.15 gpm so the flow was slightly increased. A photograph of this drain is shown in Figure 3 below;

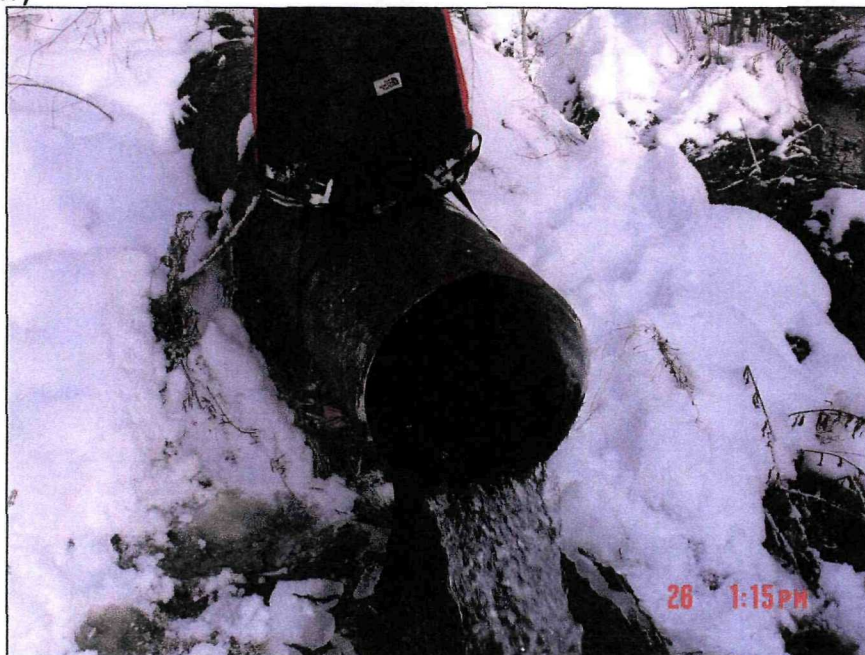
**Figure 4: Drain 6**

Drain 6: Is the large steel pipe in the center of the embankment. The flow was normal. The water depth was noted as being 11 5/8 inches down from the top inside. The November 9<sup>th</sup> measurement was 11 1/4 inches so this drain flow has decreased since the November measurement. A photograph of the drain is shown in Figure 4 below;

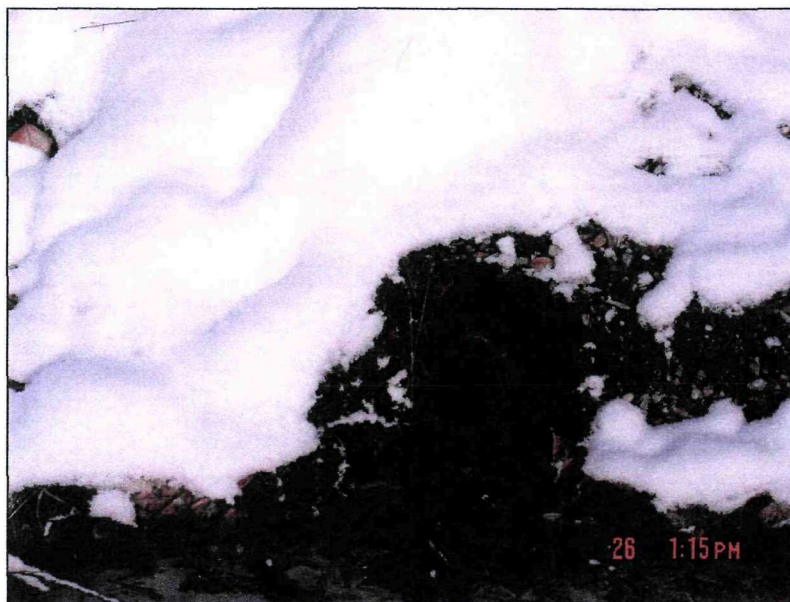
**Figure 5: Drain 8**

Drain 7 and Drain 8: Drains 7 and 8 are located together on the right side of the center of the embankment. Drain 7 is on top of Drain 8. Drain 7 is typically dry and was dry at this time. Drain 8 is an old CMP that is half buried in the silts. Drain 8 had a small amount of flow. Drain 7 was covered with snow and a photograph was not practical. Drain 8 is shown in Figure 5 below.

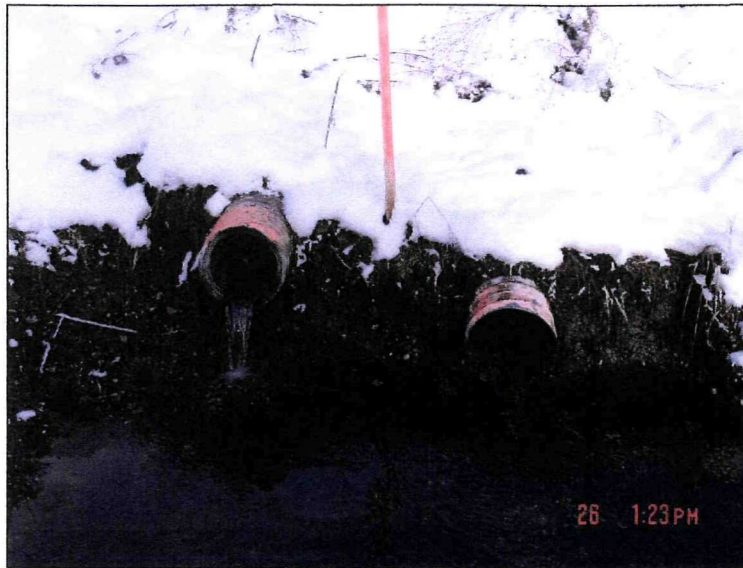
**Figure 6: Drain 9 and Drain 10**

Drain 9 and Drain 10: are a pair of drains located approximately 100 ft. left of the right groin. Drain 9 is a CMP and Drain 10 is a concrete pipe drain. There was water flowing from both drains which is typical of these drains. The flow is clear. Photographs of the drains are shown in Figure 6 below. Figure 7 shows a close up of each drain.

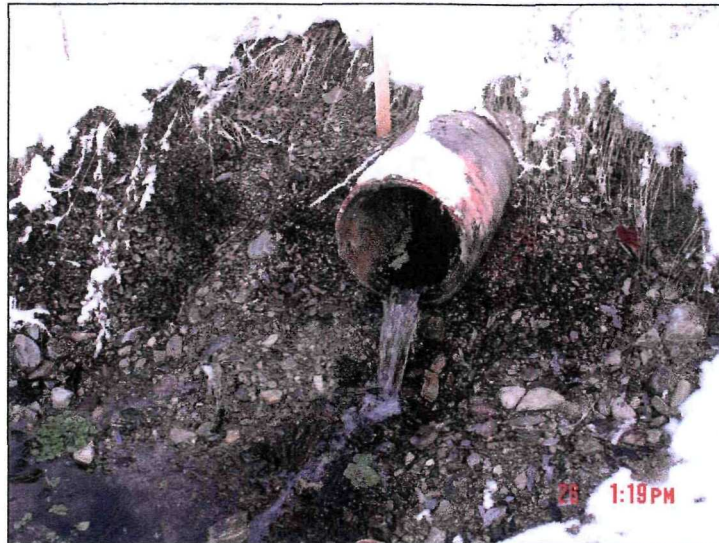
**Figure 8: Drain 11**

Drain 11: Drain 11 is an 8-inch concrete pipe. The drain was flowing water as is typical of this drain. The flow was clear and was a normal amount. A photograph of the drain is shown in Figure 8 below:

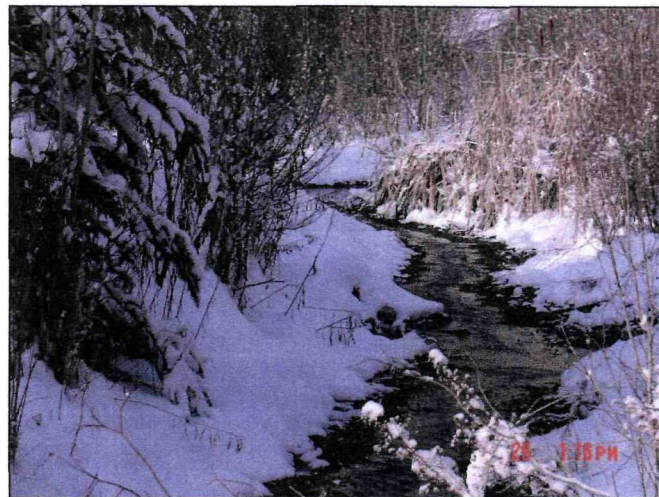
**Figure 9: Stream Channel below Drain 11 and Drain 12**

Drain 12 was covered with snow and a photograph was not practical. The V-notch weir below the drain was read and the reading was 1-3/4 inches which corresponds to a flow of 9.43 gpm. The flow in November was also 9.43 gpm. The stream channel below Drain 11 and Drain 12 had the normal amount of water flow below the drains. The channel is shown in Figure 9 below.
